Geotechnical Site Visit Report

Project Name: I-90 East of Hyak to Snowshed Phase 1B					
Contract No: C-7852	Page	1	of	1	Pages
Day: Thursday	Date: 9/15/11

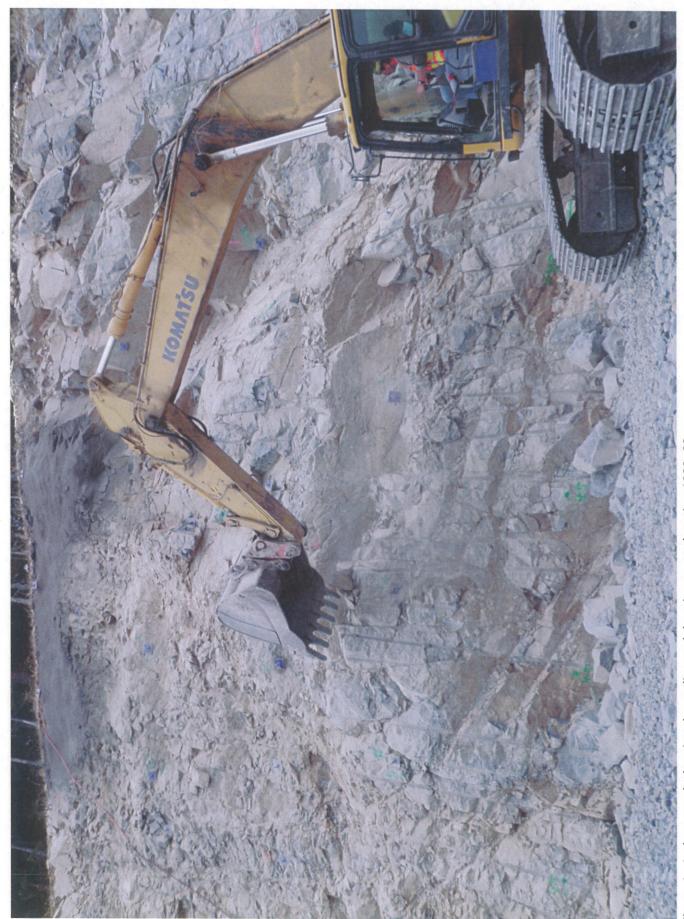
I spoke with Erik Warren by telephone and he indicated that we could lay out rock dowels around Jenkin's Knob. I met Erik on the east end of the project around 8:30 am. KLB indicated that some scaling and dressing needed to be done around station 1332+00 and he had a piece of equipment headed to the top to begin scaling (Figure 1).

Figure 1. A photograph showing the scaling and dressing around station 1332+00.

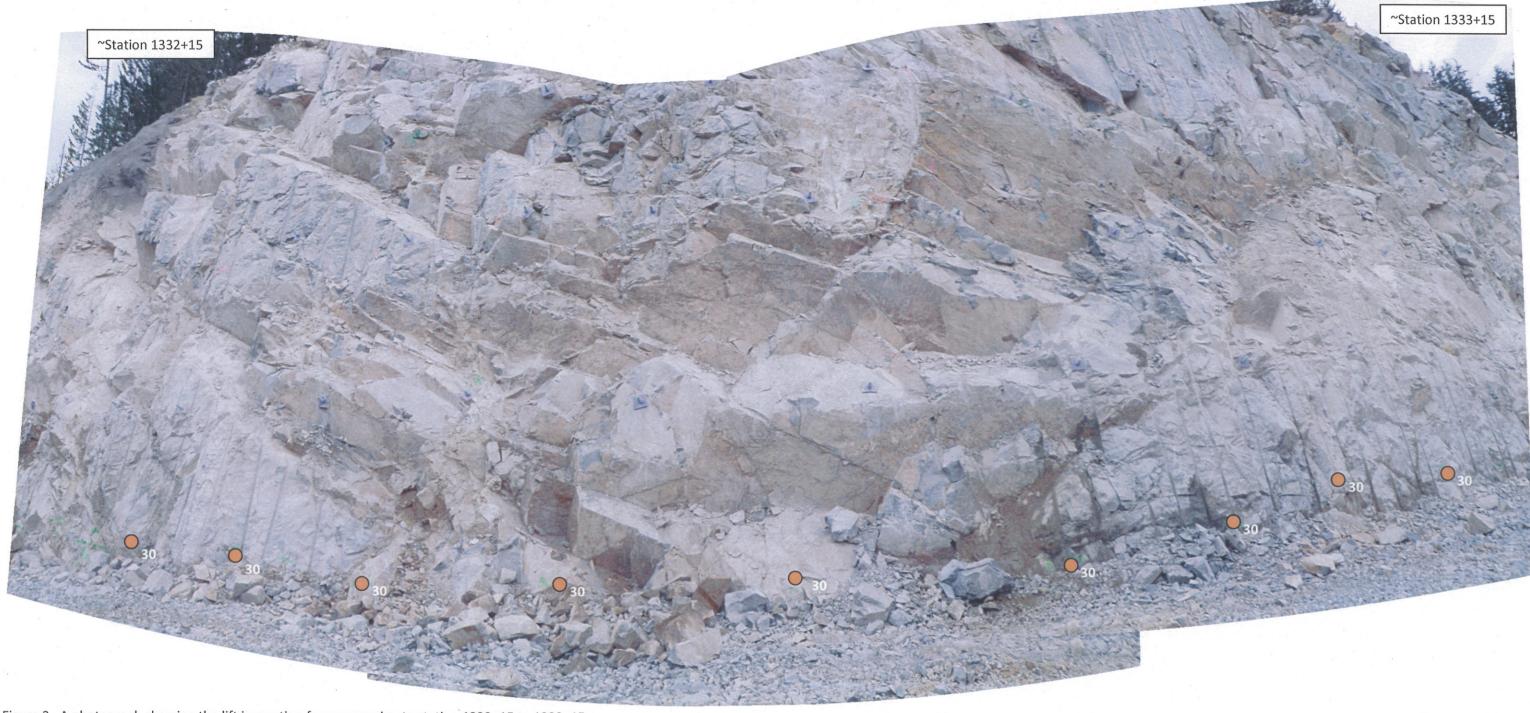
Following the scaling and dressing, Erik and I laid out 18 – 30 foot Type H rock dowels and 1 Type L spot dowel from approximate station 1332+15 to 1334+40 (Figures 2 and 3). The presplit holes continue to drift in and out of the slope and horizontal spacing was not consistent as we have seen in the past. We were also able to lay out 4 Type L rock dowels from approximate station 1330+50 to 1330+85 (Figure 4). There is an approximately 25 foot-long hard toe that needs to be shot during the next pre-split (Figure 4 and 5).

Figure 2. A photograph showing the lift inspection from approximate station 1332+15 to 1333+15.

30 - Type H Rock Dowels (Minimum Length in Feet)

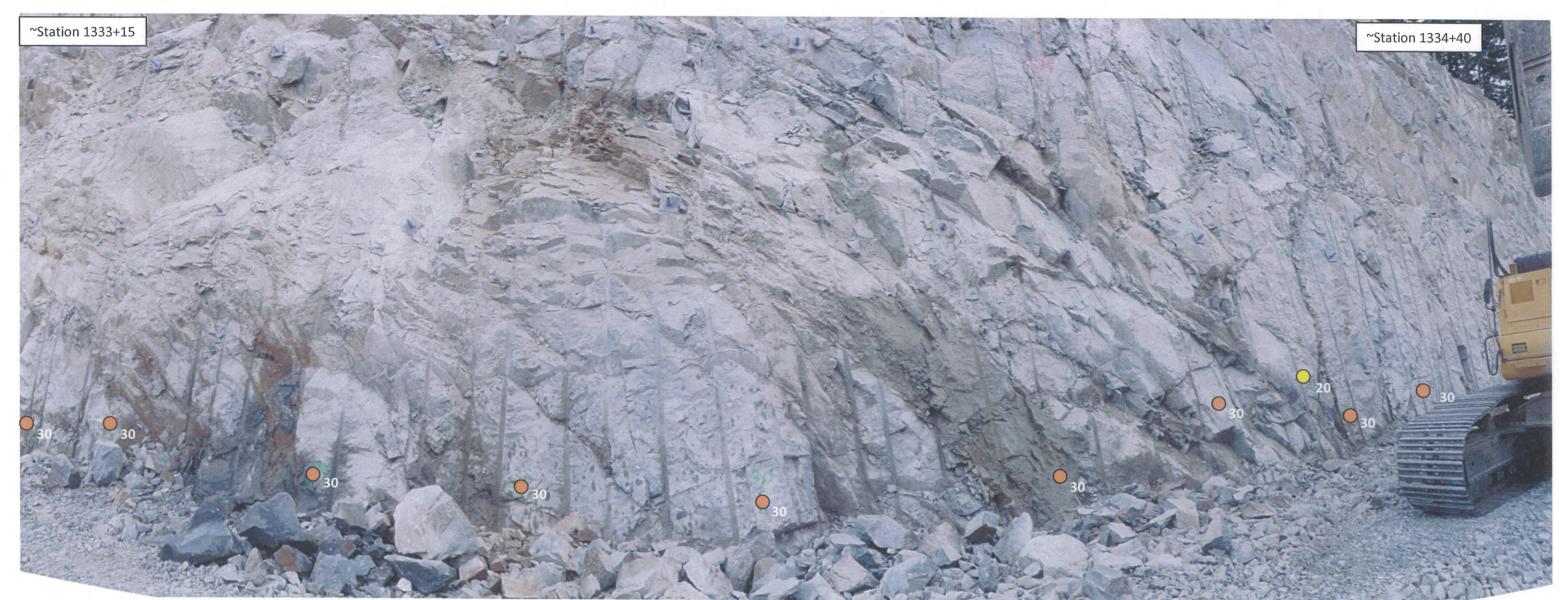
Figure 3. A photograph showing the lift inspection from approximate station 1333+15 to 1334+40.

30 - Type H Rock Dowels (Minimum Length in Feet)

20 - Type L Spot Dowel (Minimum Length in Feet)

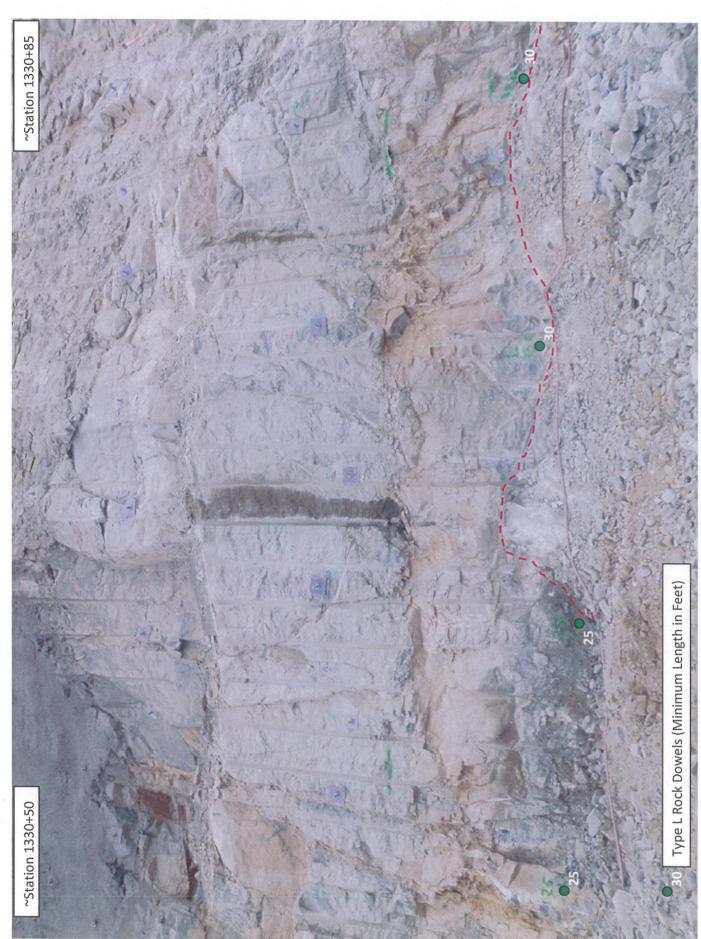
Figure 4. A photograph showing the lift inspection from approximate station 1330+50 to 1330+85. Note the hard toe (red dashed line).

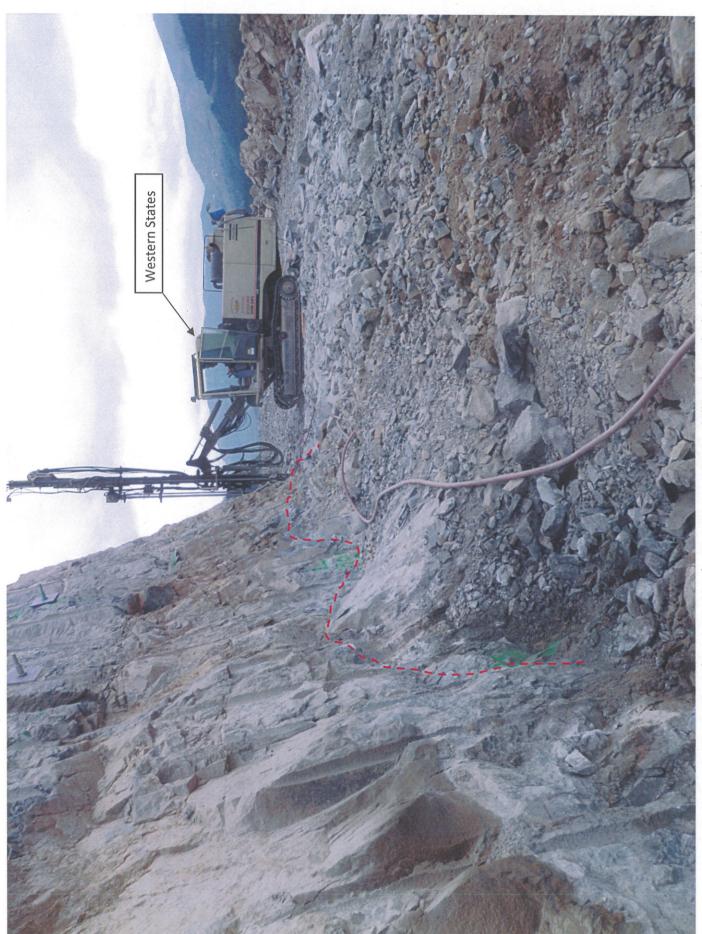
While we were on-site, Western States drilled the final probe hole around station 1331+00 at approximate elevation 2577 MSL (Figure 5). The driller indicated that he drilled a vertical hole 58 feet deep and did not hit any voids or large seams. He stated that he would send his boring log to Erik Warren and he would forward it to the Geotechnical Division.

Figure 5. A photograph showing the hard toe (red dashed line). Note Western States drilling the probe hole in the background.
